Steam Schooner
WAPAMA
HISTORIC STRUCTURE REPORT
1986

Steam Schooner
WAPAMA
HISTORIC STRUCTURE REPORT

**The National Maritime Museum at San Francisco
The National Park Service,
Golden Gate National Recreation Area
Fort Mason, Building 201
San Francisco, California, 94123**

**Tri-Coastal Marine, Inc.
(White Elephant Management)
2104 Strand, Galveston, Texas, 77550**

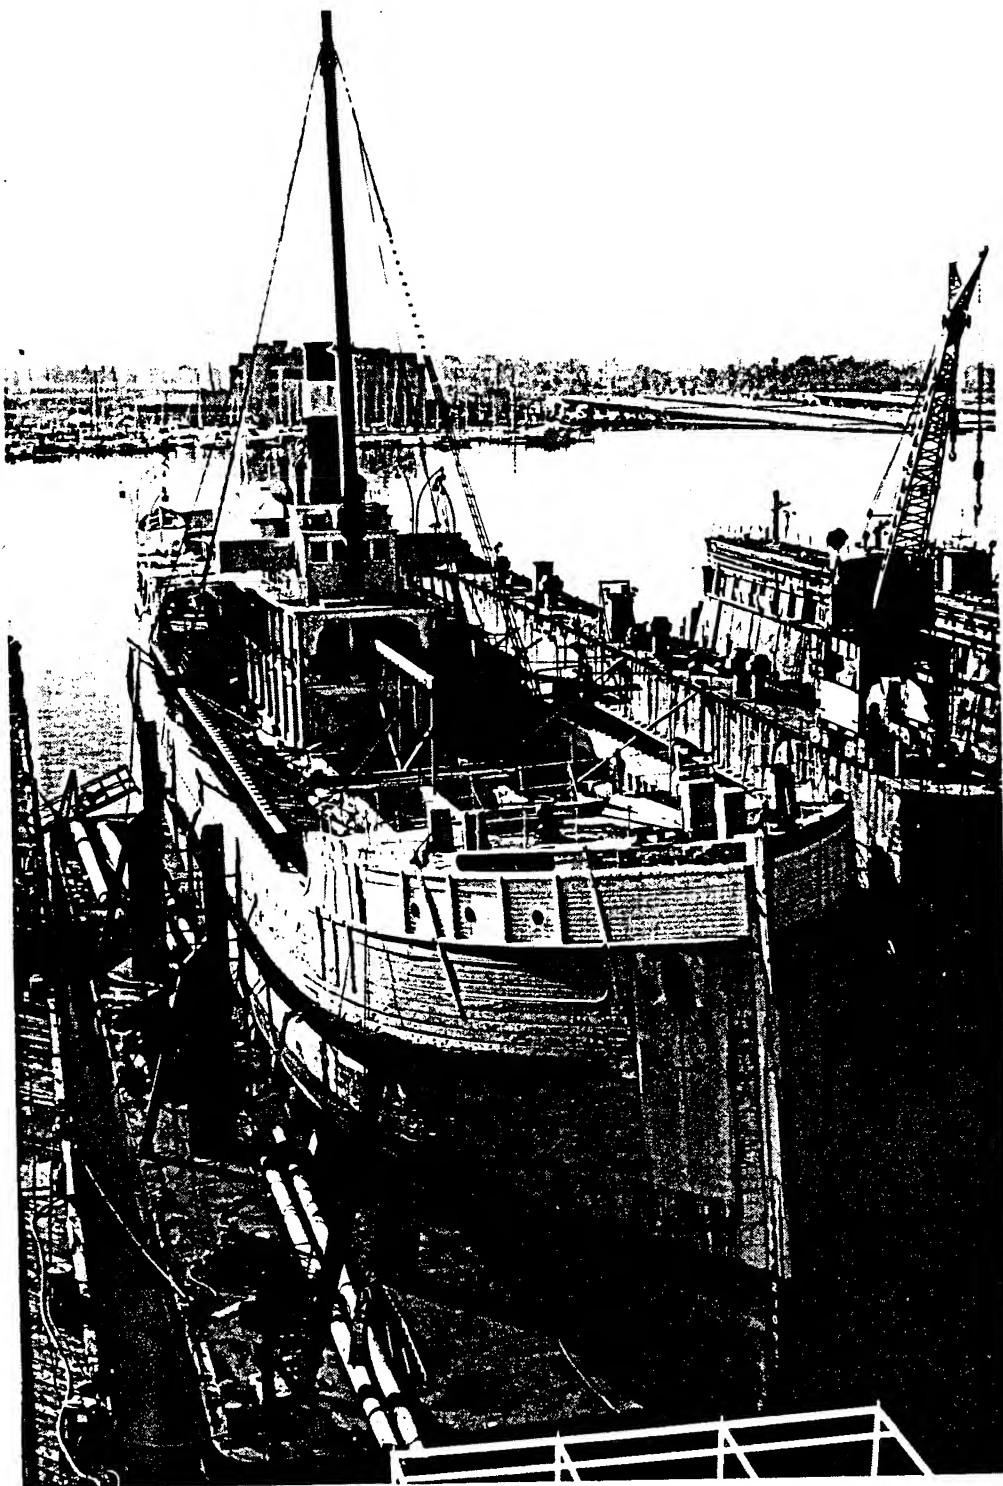
Fig. 9. WAPAMA at Pacific Drydock, December, 1885. Weather cover over main deck in process of installation.

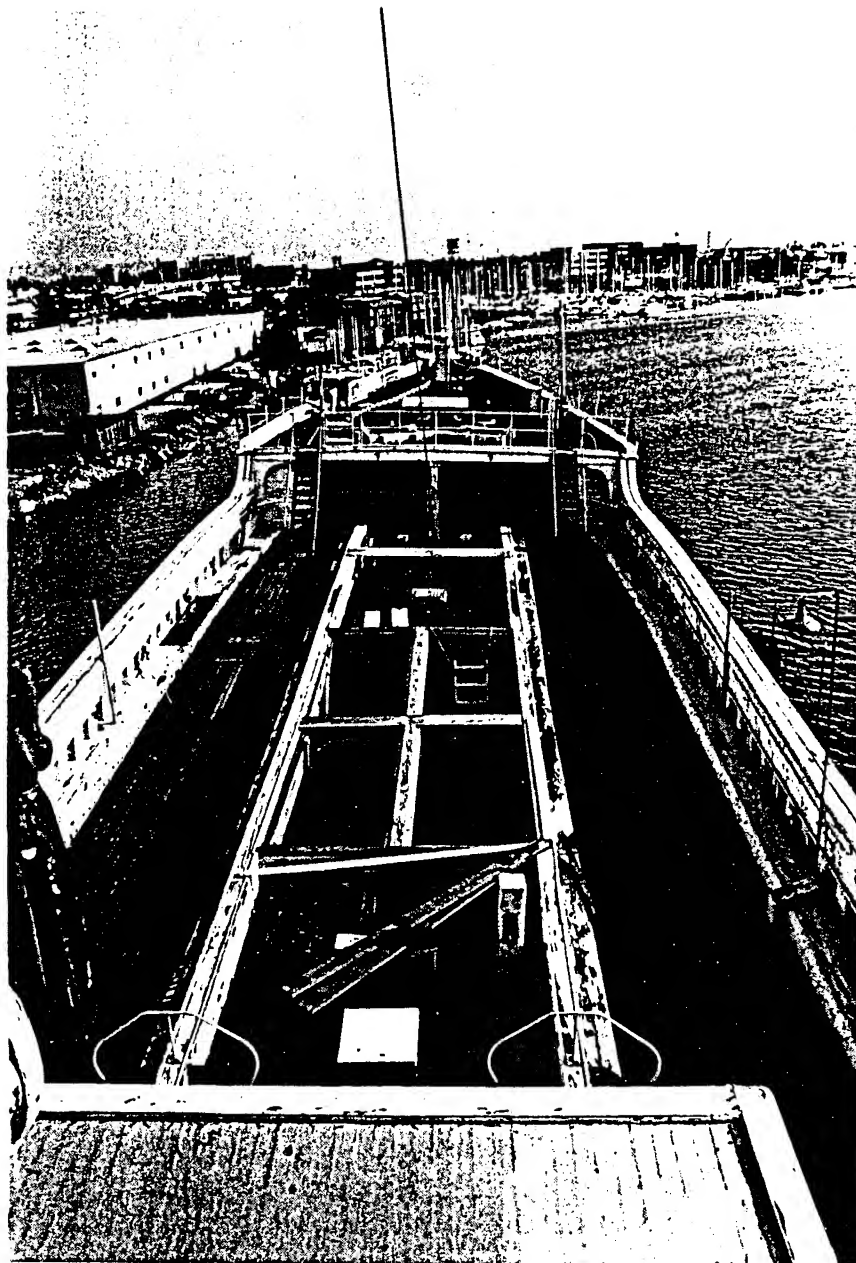
Fig. 11. View of main deck from top of wheel house. This deck is presently covered by roof structure. --Photo, TCM

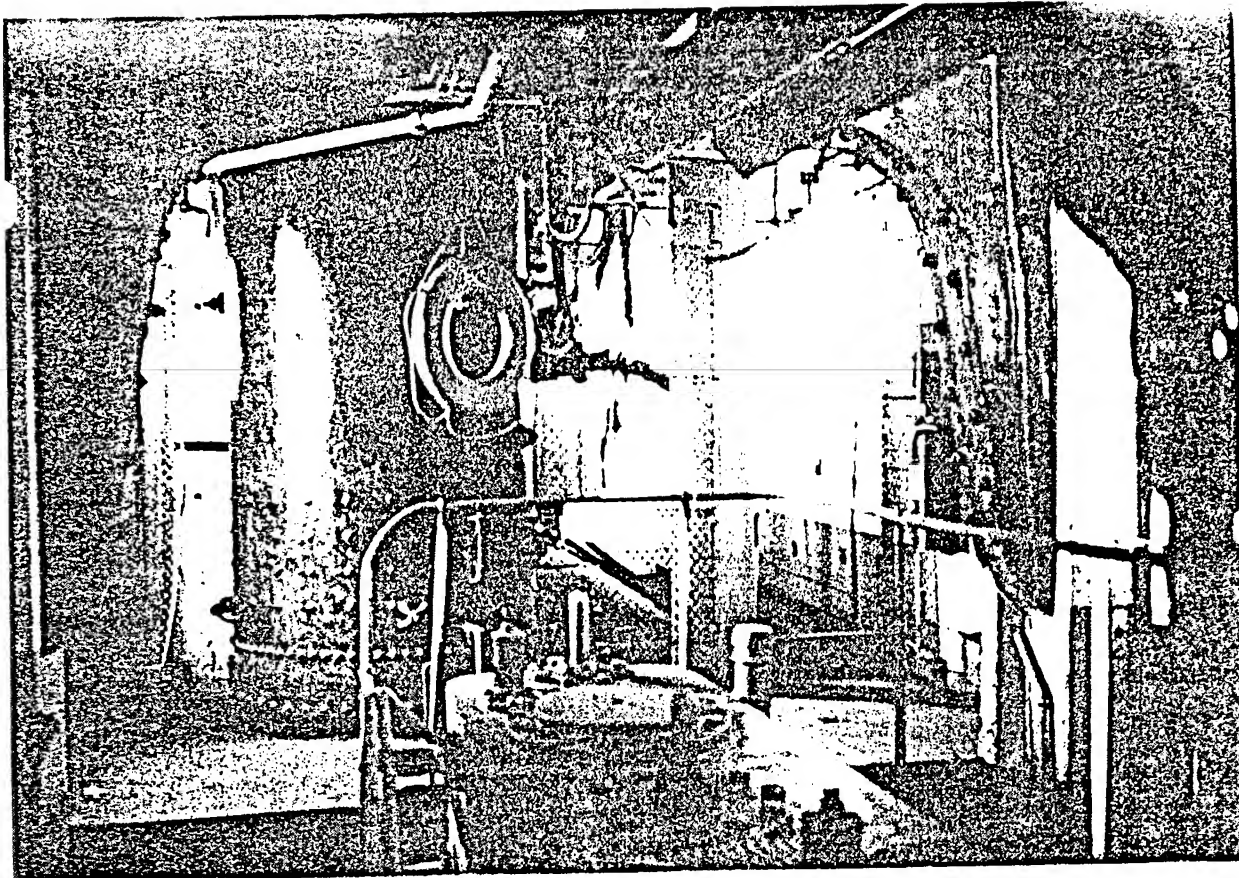
Fig. 14. Main deck engine flat, looking forward. Steam chest is in center foreground, donkey boiler past it to the left. Ventilators port and stbd, and stbd side of boiler breeching visible beyond. Note heavy knees port and stbd.

Overall, the main deck house is in marginal condition. This structure is not presently in danger of collapse, but additional support or repairs will be necessary if ongoing deterioration is not abated. Of primary concern here is the collapsing stack and boiler breeching. Though the stack can be temporarily supported by adding steel brackets, a permanent solution will involve removal and rebuilding of the stack, and renewal of wood structure in the fidley. The recently installed covers have partially alleviated rainwater seepage, though additional covers are needed over the steel fidley trunk and boat deck. Removal and replacement of rotten tongue and groove sheathing will help make the house weather-tight again, and will allow inspection of timber studs in the sides of the house.

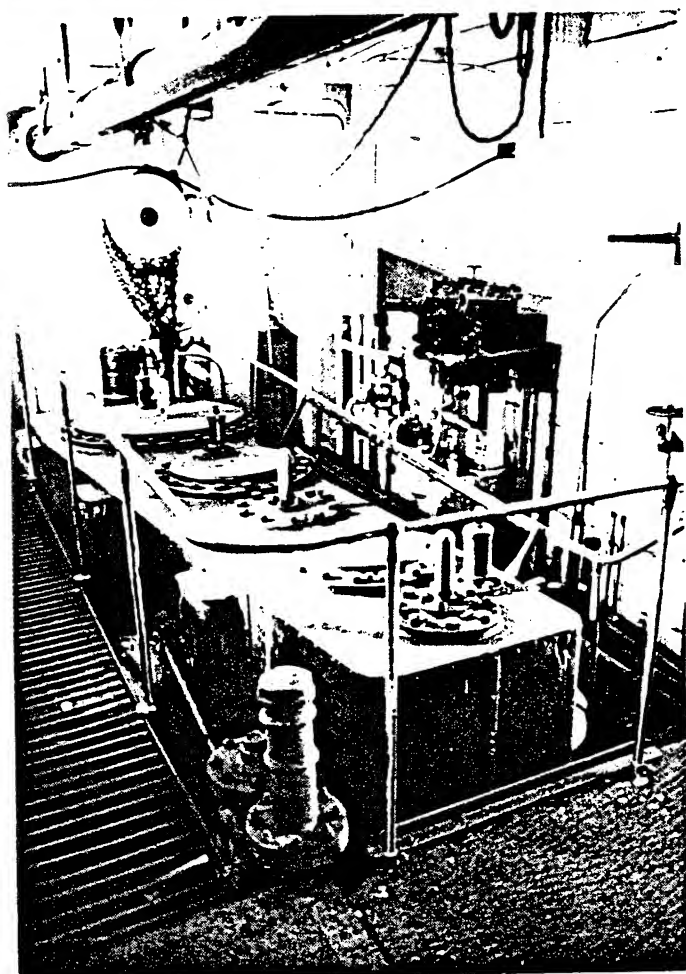
Fig. 15. Main deck engine flat, looking aft. Top of engine, steam chest, is enclosed by pipe rail.

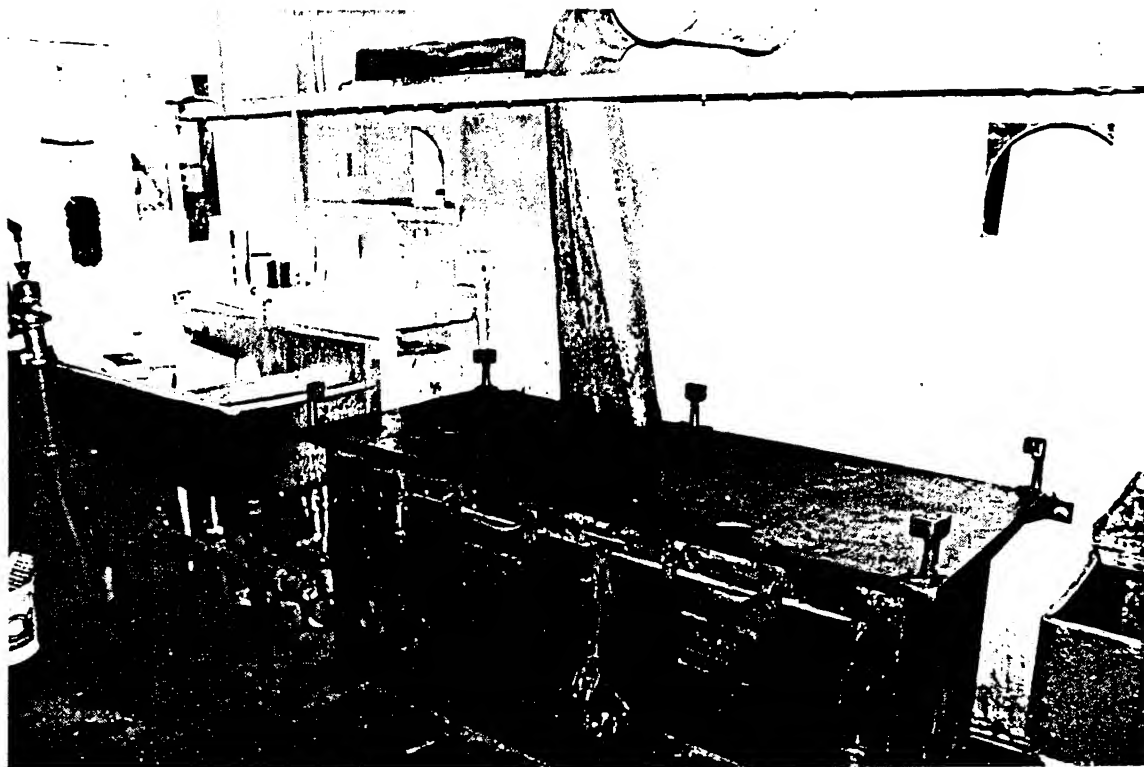
Fig. 17. Galley looking fwd. Stove pipe pierces steel blkhd into engine room fwd.

Fig. 18. Pantry, looking to stbd.

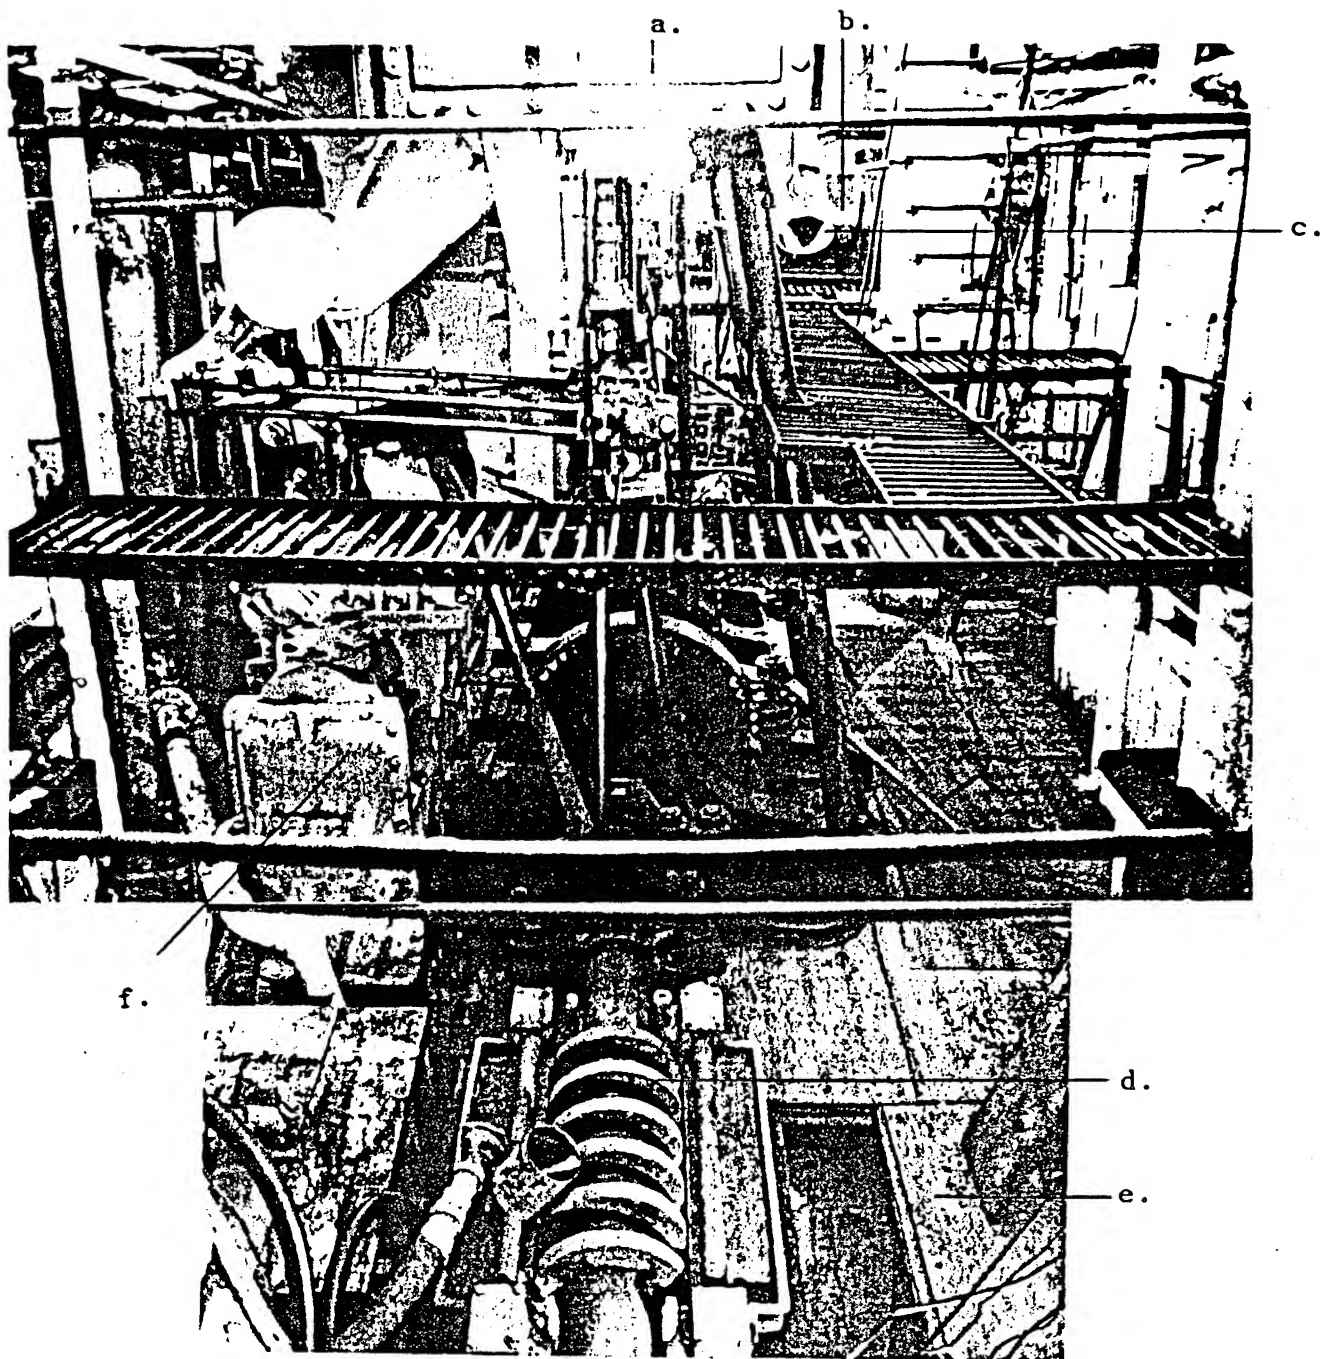
The hull has suffered damage due to a fire in way of the starboard fuel tank. In this area, frames 61 to 63, eight ceiling strakes have been almost completely burned away, frames are damaged, and the fuel tank foundation timber is burned and decaying. Much of the ceiling below the turn-of-bilge could not be inspected due to limited access in way of the fuel tanks, boilers, and machinery flats. Where inspection was possible, these strakes appeared much like those in the cargo hold, with extensive rot, and nail sickness around fastenings.

The upper ceiling strakes and clamps, and the underside of the main deck are suffering from severe surface deterioration, primarily in way of the fuel tanks. This deterioration, which appears as a "fraying" of the surface grain, is thought to be non-fungal in nature. All three clamps and the upper three ceiling strakes are generally rotten behind the hanging knees from frame 56 to 67 on the port side, and from frame 51 to 63 on the starboard side. Areas of advanced rot were also seen in the lower ceiling strakes at the aft bulkhead, port and starboard.

Fig. 21. Engine room, looking fwd. (Composite photo)
 a. steam chest. b. stbd steam drum c. bottom of ventilator
 d. thrust bearing e. engine room flat f. condenser

The keelson, rider keelsons, and assistant keelsons could not be viewed in some areas. Generally these members are in fair condition in way of the engine, and in poor condition under the boilers. The first rider keelson is badly deteriorated where it ends at frame 54, between the boilers. The keelson is soft and limbnoria damage can be seen at frames 69 to 71, aft of the engine. The two longitudinal boiler bearer timbers under each boiler are severely rotten and collapsing. The engine foundation timbers are in good condition. The machinery flat (platform) on the starboard side is in fair condition.

Extensive and ongoing rot is seen in the main deck structure in way of the engine room. Of the fifteen main deck beams in this compartment, twelve are severely rotten at the port and starboard outboard ends, and variously along the inboard lengths. All full deck beams and half-beams in way of the engine and boiler "hatches" are moderately to severely rotten at the carlings. The carlings are also in generally poor condition due to rot, and all adjacent lodging knees have been affected. The beam at the forward bulkhead, and the aftermost two beams show only moderate rot. Previous attempts have been made to reinforce weakened deck beams. The beams at frames 60 and 69 have been sistered with steel plates, and shoring has been installed inboard and in way of the fuel tank. Additional measures will be necessary as decay progresses.

The engine room presents a challenge for both preservation and interpretation. This compartment is presently considered unsafe, even for volunteers and crew. The first priority should be to correct safety deficiencies in order to begin preservation work. A major program of documentation and removal of wasted machinery and piping should be undertaken before further collapse prevents proper recording of these artifacts.

Preservation of the wood structure should begin with weatherproofing. This can be achieved in the short term by addition of covers over the decks and fidley above. Even if freshwater is stopped, drying will be slow due to the poor ventilation here. The drying process can be speeded up by selective use of forced air ventilation. Even so, ongoing decay will likely necessitate some repair, and possibly renewal, of deck beams and stanchions.

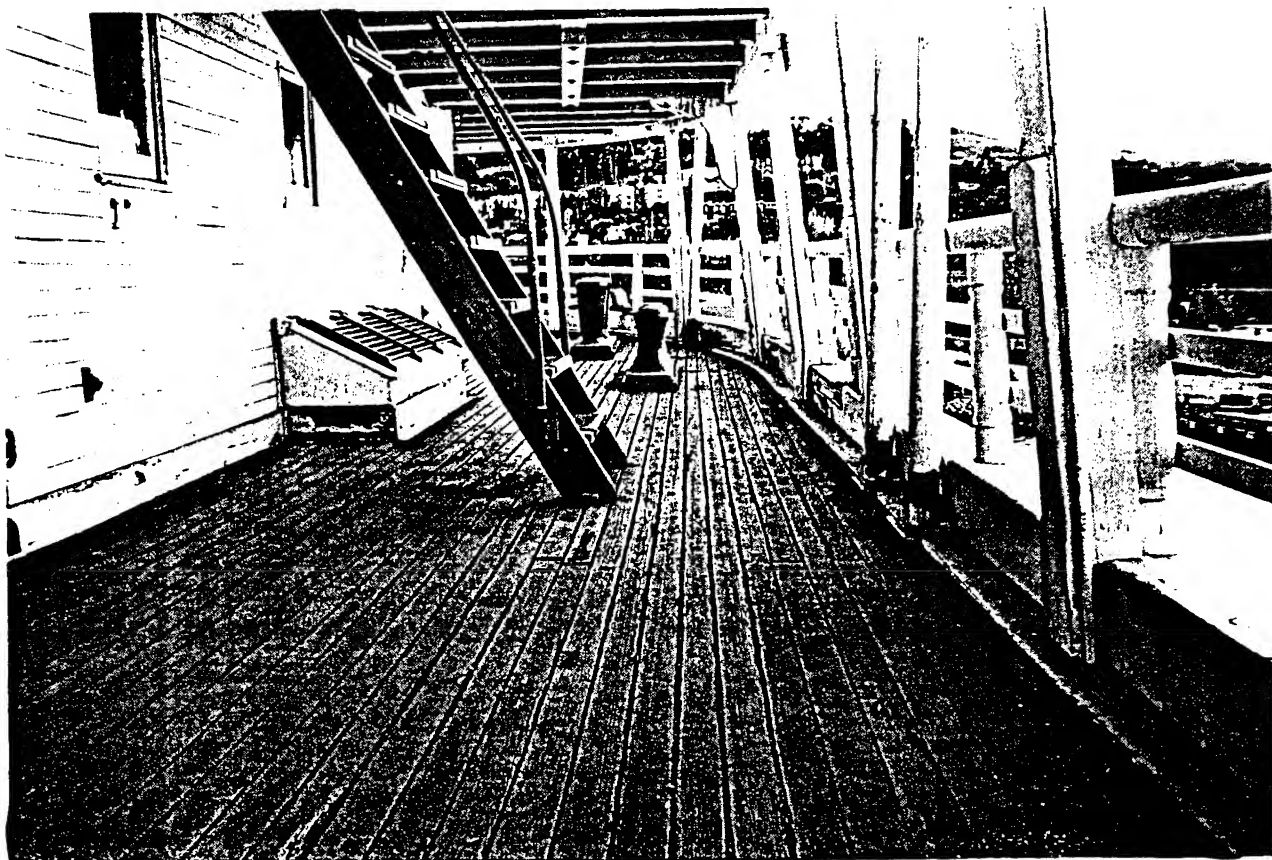
The worst deterioration seen in the cabin deck is found in the exposed exterior areas, particularly on the port side, from the poop bulkhead to the stern. Here, the solid bulwark timber is severely rotten and disintegrated over a distance of 24 feet, from the port quarter chock to the stern. The port covering boards are rotten variously with the worst area at the quarter. The poop bulkhead covering board is rotten at the port outboard end. The cap of the raised bulwark, forward of the poop bulkhead on the port side, is rotten variously from frame 64 to 70. Localized areas of rot are seen in the deck planking near the deck edge on the port quarter, and around bitts and skylights.

Four of the turned pillars supporting the boat deck on the port side, number 2, 3, 4 and 5 counting from the poop bulkhead, are rotten at the bases and structurally unsound. The aftermost of the port side davits is adrift at the base and presents a hazard.

Fig. 24. Cabin deck, port side, looking aft.

The cabin deck planking aft of the poop bulkhead is only marginally sound, though no areas were seen to be seriously weakened. Numerous rotten deck planks were noted, particularly outboard on the port side. The entire exterior cabin deck is open at the seams and leaking rainwater into the vessel interior.

The boat deck should be temporarily shored in way of the rotten pillars on the port side, until the pillars can be repaired. Loose davits should be secured or removed. The severe rot seen in the fidley will require attention. This structure is a prime candidate for rebuilding because of its role in supporting the weight of the stack in the original manner.

The leaking deck could be reaulked with minimum plank renewals, though this alone could not prevent rainwater seepage into the accommodations areas. The severe deterioration along the port side of the deck will necessitate at least partial renewal in order to achieve this. In the short term, the addition of weather covers over the fidley trunk on the boat deck, and side curtains around the exposed areas of the cabin deck will do much to keep water out and slow the ongoing deterioration.

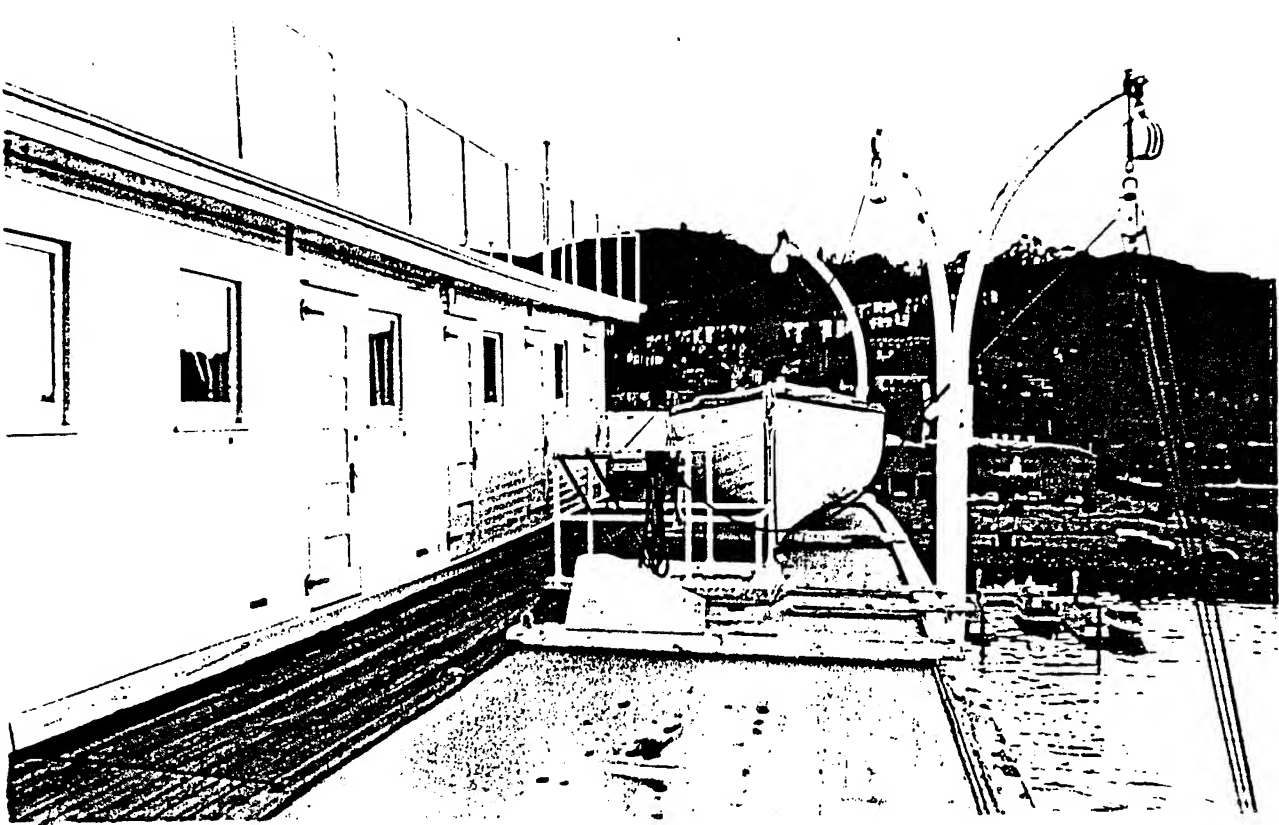
Most boat deck beams and decking are in good condition, with the exception of an area at the starboard deck edge between frames 58 and 61, in way of the fidley trunk. Here the deck edge stringer, two deck beams and outer deck planks are rotten due to poor drainage.

Torn areas are seen in the canvas deck covering, forward of the pilot house and in several areas near the deck edge. The quarter-round molding at the covering boards is soft or rotten throughout. The covering boards themselves are generally sound, except for the rot seen around the port access ladder deck opening.

Fig. 27. View of boat deck, port side, looking aft.

The boat deck area should be considered a preservation priority because of the relatively intact state of the structure. The ongoing deterioration, due to rainwater seepage, will eventually result in costly repairs or loss of structure. The most effective means of preventing this would be to place a weather cover over the entire deck. If this cannot be done, individual covers should be placed over the pilot/chart house, fidley trunk, and boat deck house. In addition, areas of torn canvas decking should be repaired, and standing water eliminated by installation of scuppers. The two lifeboats should be covered or removed to protective storage. The two transom boats should also be protected, even if rebuilding or replication is planned.

Although the boat deck is presentable for public display at this time, access should be limited until the weakened support pillars on the port side (noted in section Cabin Deck) are repaired or reinforced.

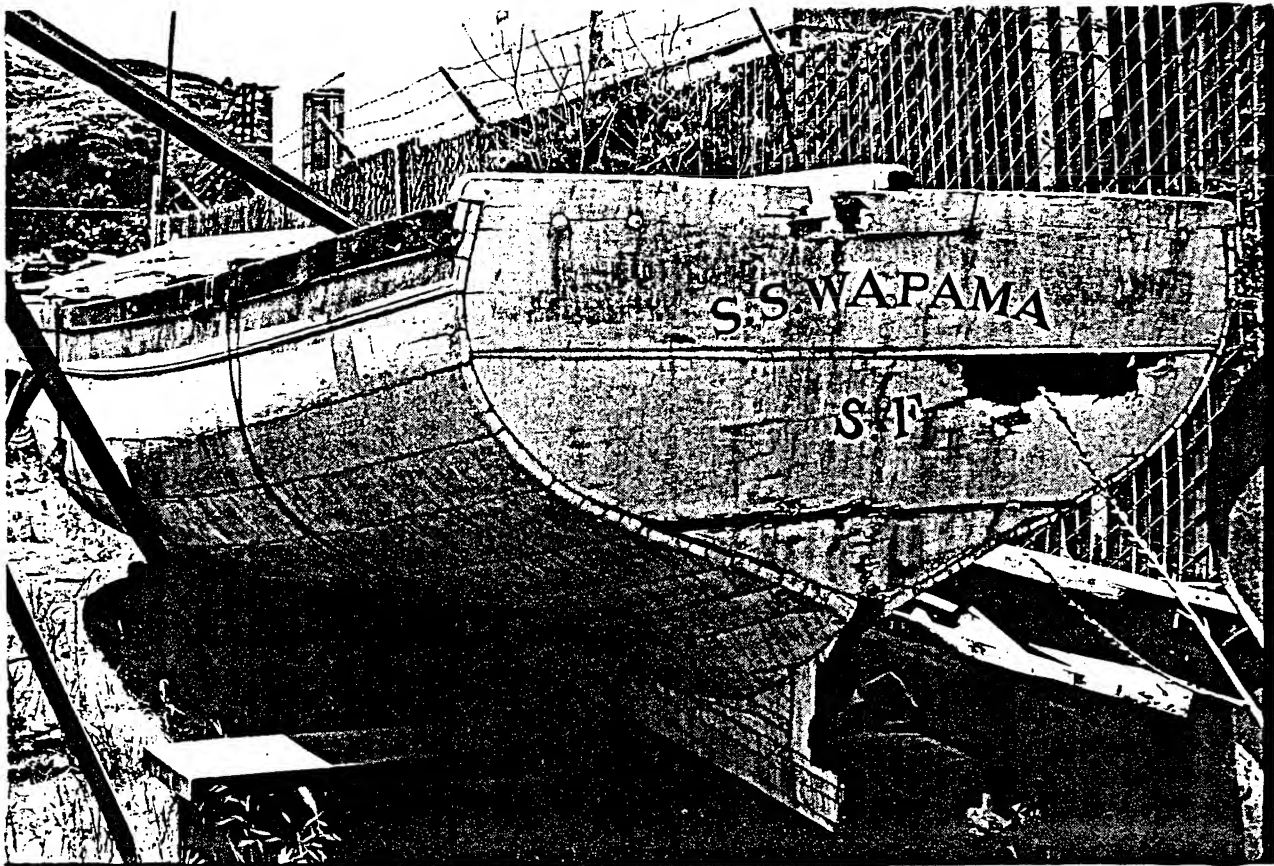
Fig. 28. Transom stern launch removed to shore. --TCM

The two composite wood and steel lifeboats are in poor condition and are exposed to the weather. The wood portions, including stem, keel and sternpost are rotting, and the sheet steel hulls are rusting. The two transom stern wood boats, formerly stowed on the boat deck, have been moved ashore where they also remain exposed to the weather.

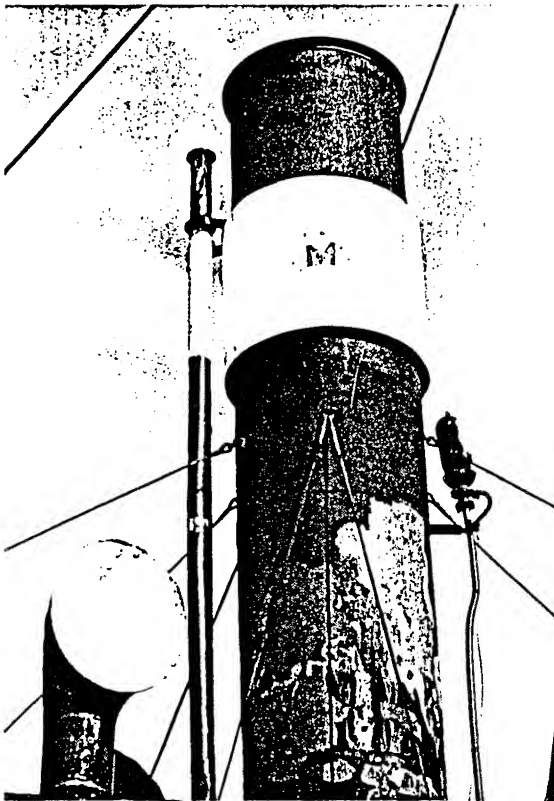
The steel fidley trunk has rusted through in local pits on the top, and active corrosion is seen on the ventilators. The stack above the fidley trunk is in good condition, though the iron pipes running up the aft side of the stack are corroded and coming adrift. The stack stay wires show signs of corrosion but are considered adequate for the time being.

Fig. 29. Stack.

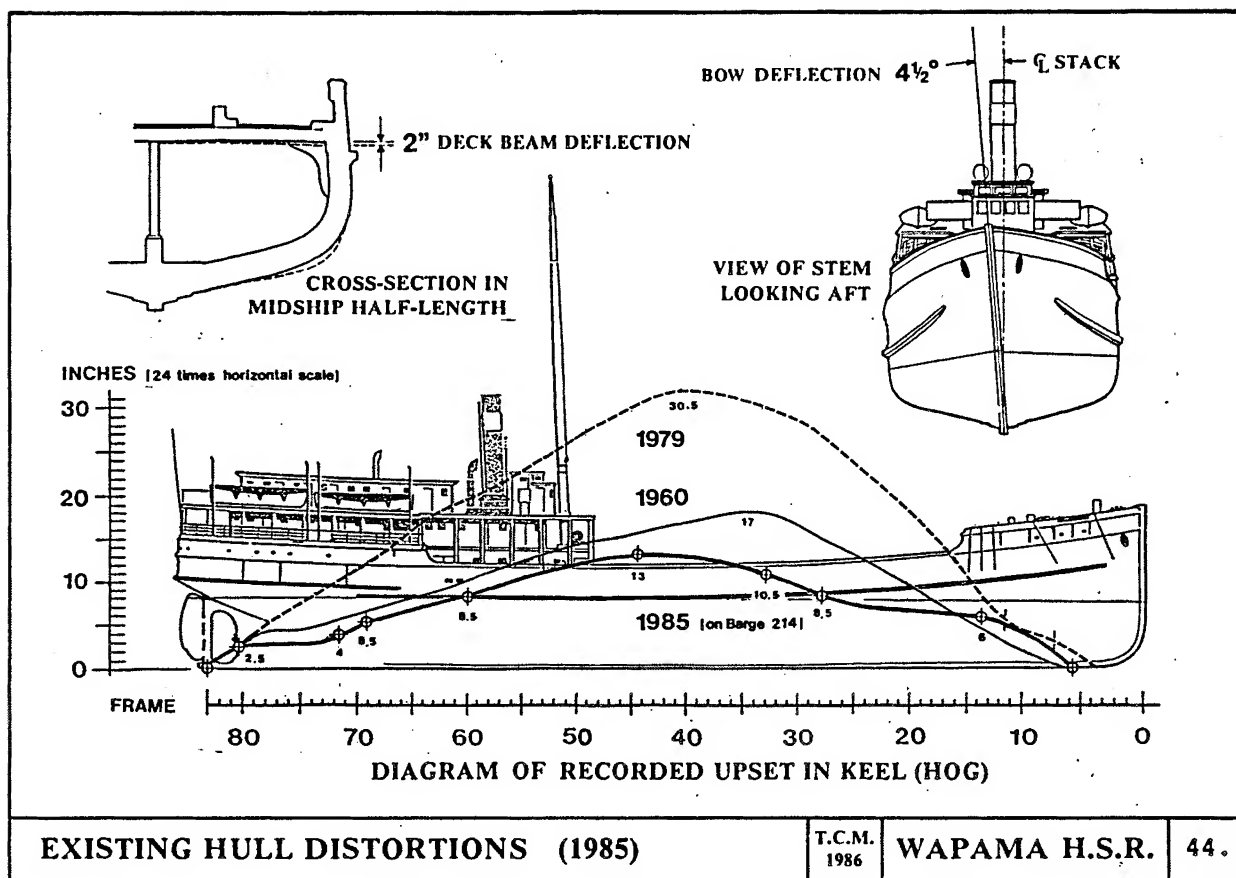
The hull surfaces below the waterline appear in surprisingly good condition considering age and length of time WAPAMA has been out of water.

The bottom planking remains generally free of rot, probably due to residual effects of years of salt water saturation. Some local areas of minor and incipient rot were seen, mostly at plank butts. Sections of hull planking were removed in 1982, at four areas of the bottom, in order to allow inspection of internal structure: frames, planks, ceiling. The inboard surfaces of many planks are seen to be abraded away between frames, by as much as 1/2". This condition may be due to a combination of decay and erosion from sloshing bilge water. The outboard planking surfaces appear rough, with widely scattered worm damage (primarily Limnoria tripunctata) up to 1" deep or 25% of total plank thickness. Most worm damaged wood has been cropped out and filled with putty, epoxy or "Portland" cement. Several planks have sprung loose at the butts, particularly at the bow and stern. Oakum caulking is generally rotten.

Approximately 40% to 50% of the iron spike plank fastenings show moderate nail sickness extending 1" to 2" around fastenings, and up to 3/4" deep. Most trunnels are still effective, though a few are seen to be partially decayed or abraded at the plank-to-frame faying surface.

The keel is generally free of decay, though it, along with the worm shoe, is being crushed by uneven loading on keel blocks. The stern and rudder posts are sound with the exception of local worm damage seen around the gudgeons. The rudder, mostly obscured by plywood sheathing, shows severe worm damage, particularly on the leading edge.

Fig. 45. View of bottom, stbd. side looking fwd, 1985. --TCM

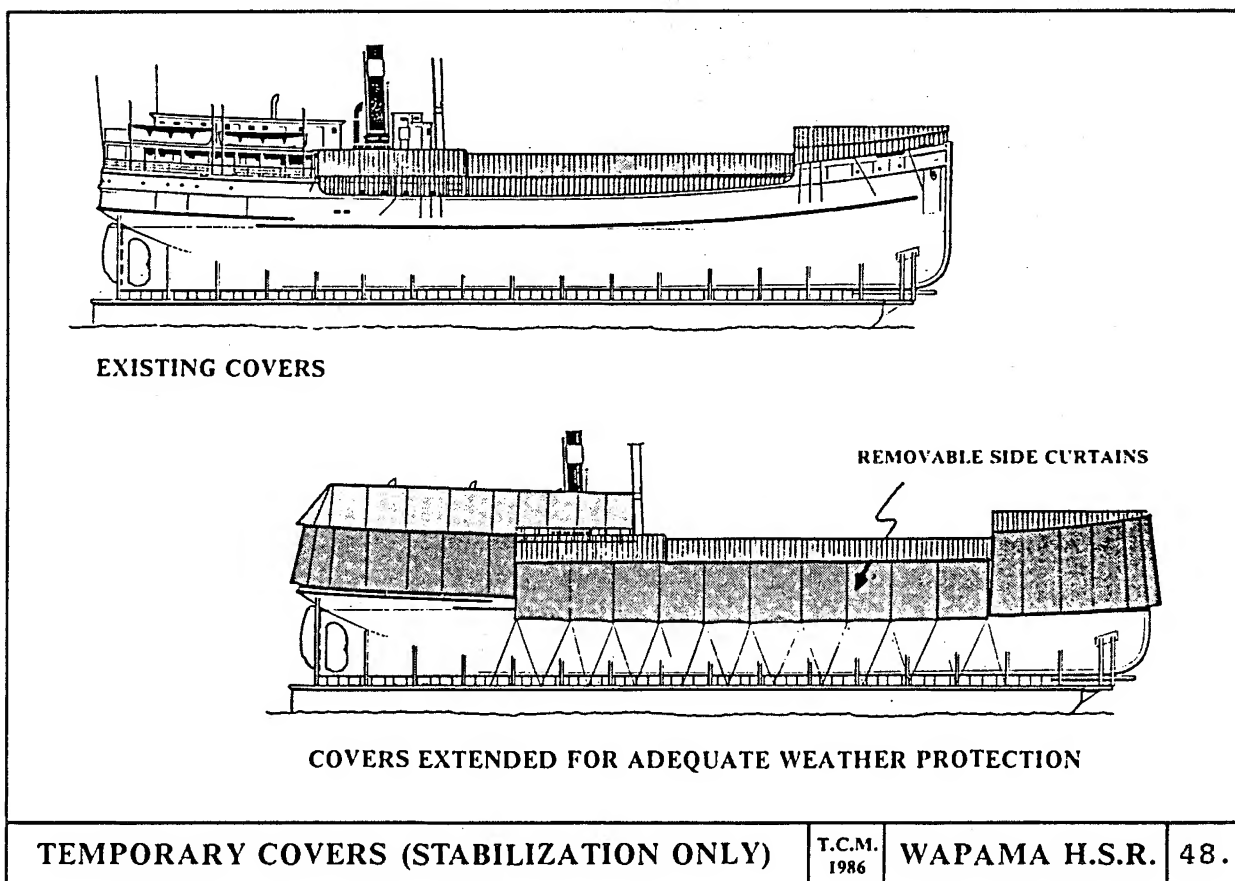
The present cover is a good start but provides only limited protection to the main deck and forecastle head, and none for the rest of the ship. The cover, as it is now, has very little overhang and even a slight angle of wind driven rain will soak the decks and pass on to the interior of the ship. In addition, protection should be provided for the porous topsides as well as the superstructure aft. This protection would be neither expensive nor difficult to achieve if use is made of reinforced plastic sheeting held in tension by a simple frame.

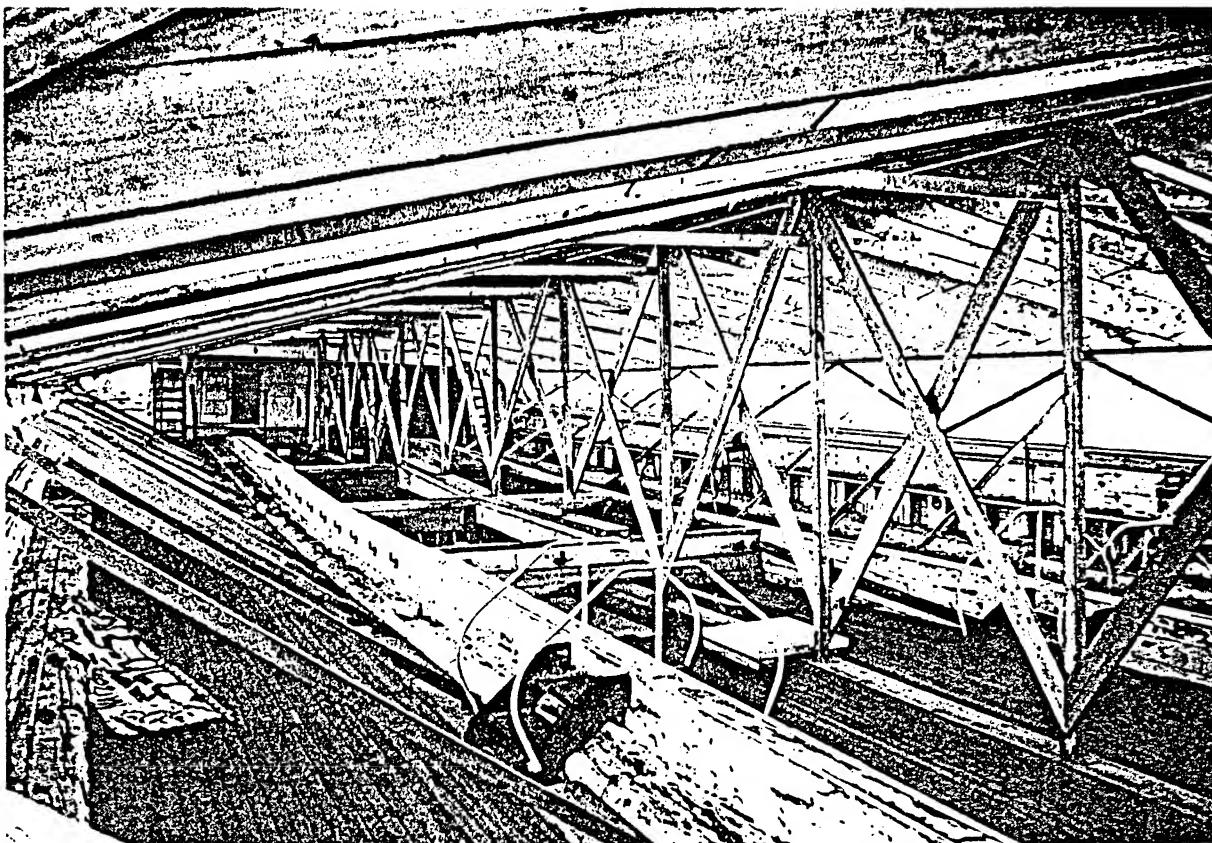
Fig. 49. Present cover over main deck. (1986)

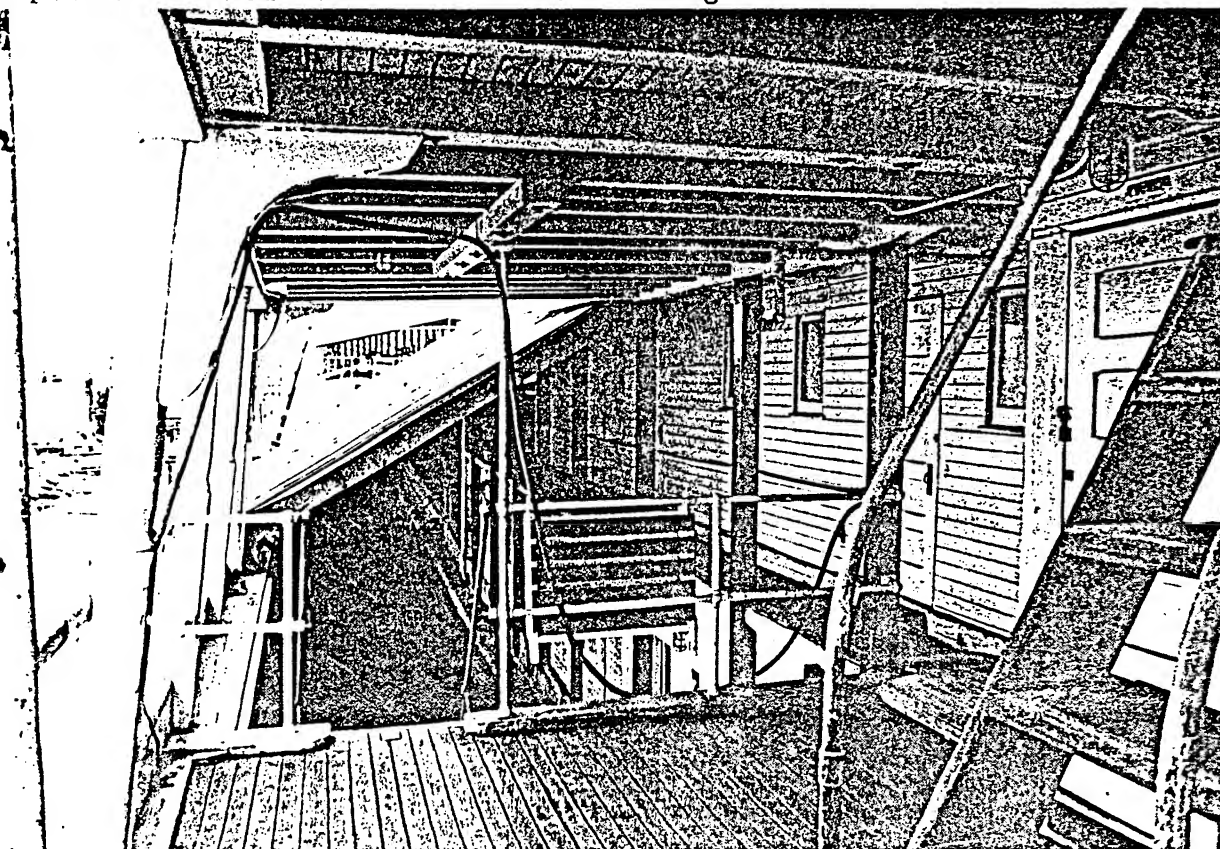
Fig. 50. View forward, port side, from cabin deck, showing compromised visitor circulation and sight lines.

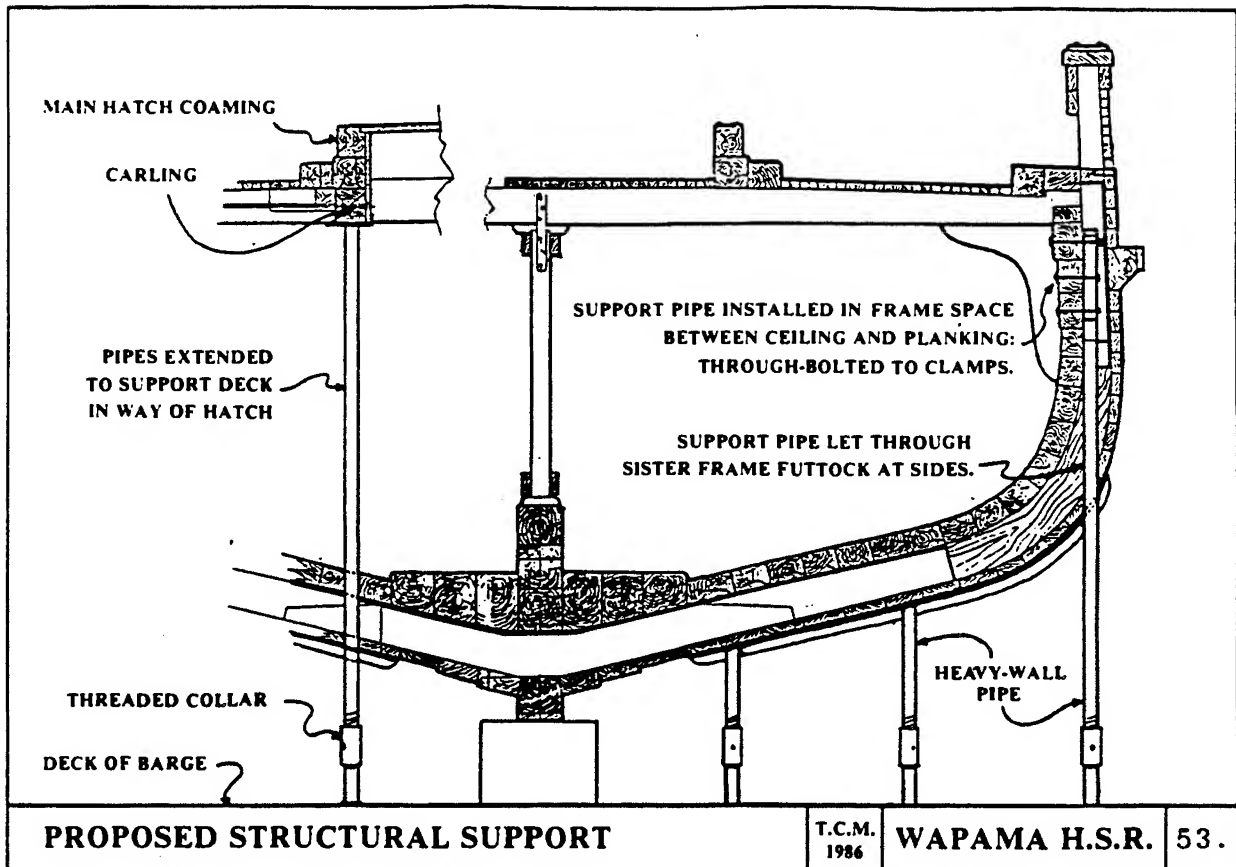
Ships are designed to be supported evenly and continuously by water. When out of water for prolonged periods of time and supported on only a few points, their own weight works very much against them. Therefore an optimum support system for the WAPAMA would simulate the support of water by providing multiple points of support rather than a few concentrated areas such as her present bilge blocking system.

Another design criteria for a permanent support system should be unobtrusiveness for the sake of interpretation. The added support should block or distract viewing of hull form as little as possible. Designing a system that is visually minimal and structurally adequate will require an engineering effort beyond the scope of this report. A suggested concept for such a system is given in figure 53.

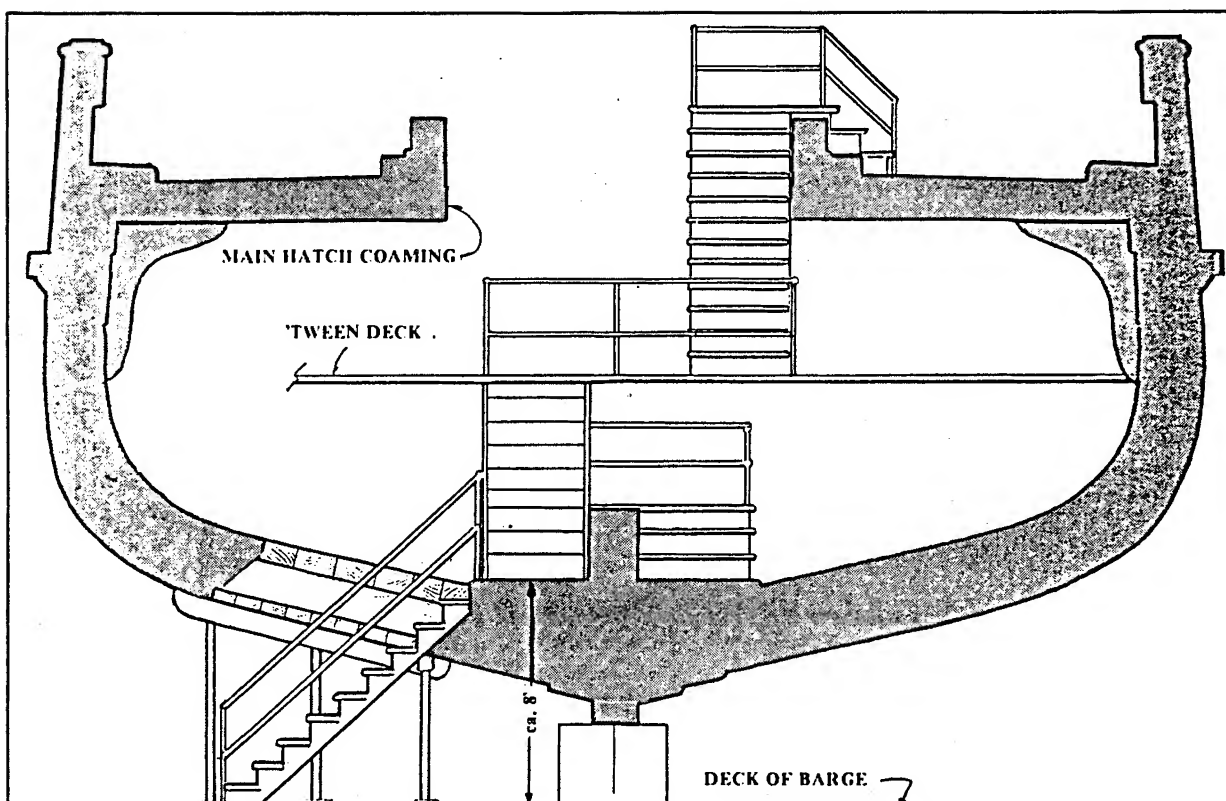
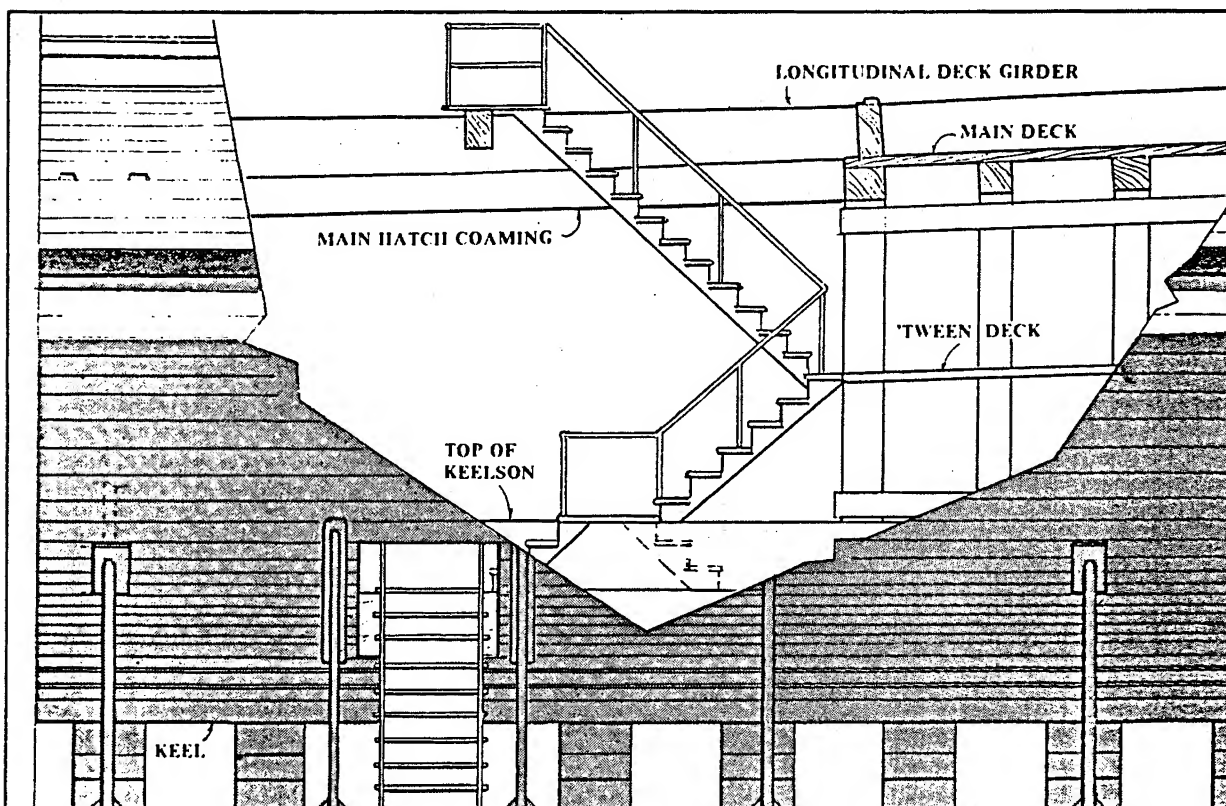
WAPAMA H.S.R. 56.

The main deck is now high above the visitors as they stand on the barge. A climb up the narrow outside stairway is required in order to reach this deck. A visit the hold requires a steep climb down again, and again back up. To alleviate this problem, it is proposed that a 7 foot square access be opened in the bottom of the hull, in way of the main hatch. (see fig. 56 and 57). The visit then begins with a dramatic view of the wooden expanse of the ship's bottom, goes through a cross-section view of the structure of the bottom, and enters several steps up into the vast curving hall that is the ship's hold. Another comfortable stairway would then lead to the main deck by way of the 'tweendeck and main hatch.

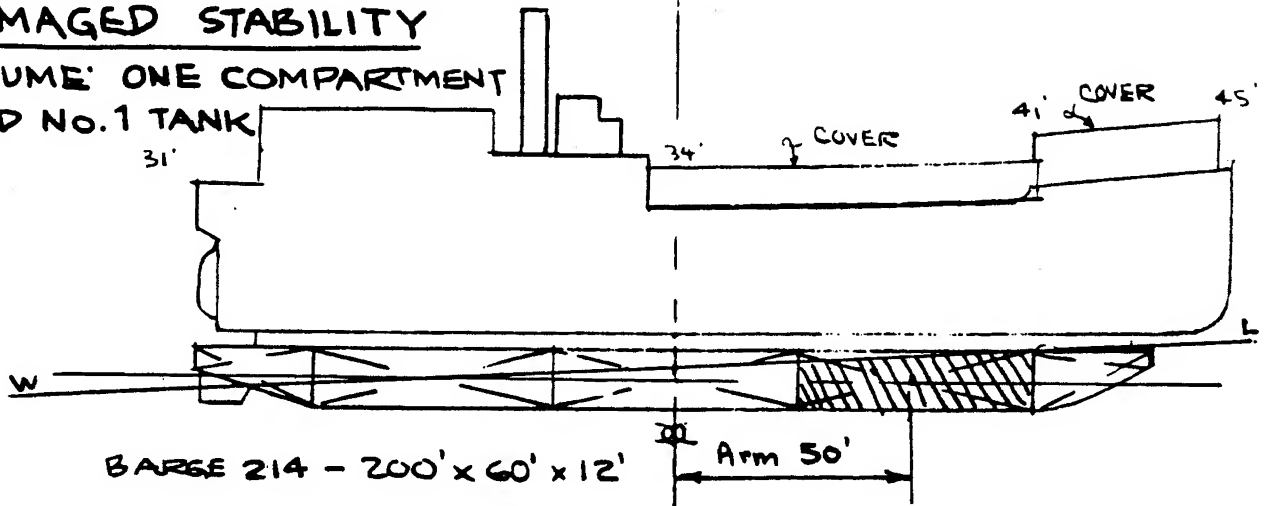
④ DAMAGED STABILITY

ASSUME ONE COMPARTMENT
FLOOD NO. 1 TANK

$$H_{\text{INTACT}} = 5.65' \quad H_{\text{DAMAGED}} = 7.53'$$

$$WT \text{ FLOODED WATER} = 12' \times 50' \times 60' / 35 = 1038 \text{ LSW}$$
